## Fair City Plaza

**Task: Diagnose problems, recommend improvements for small municipal district cooling system**

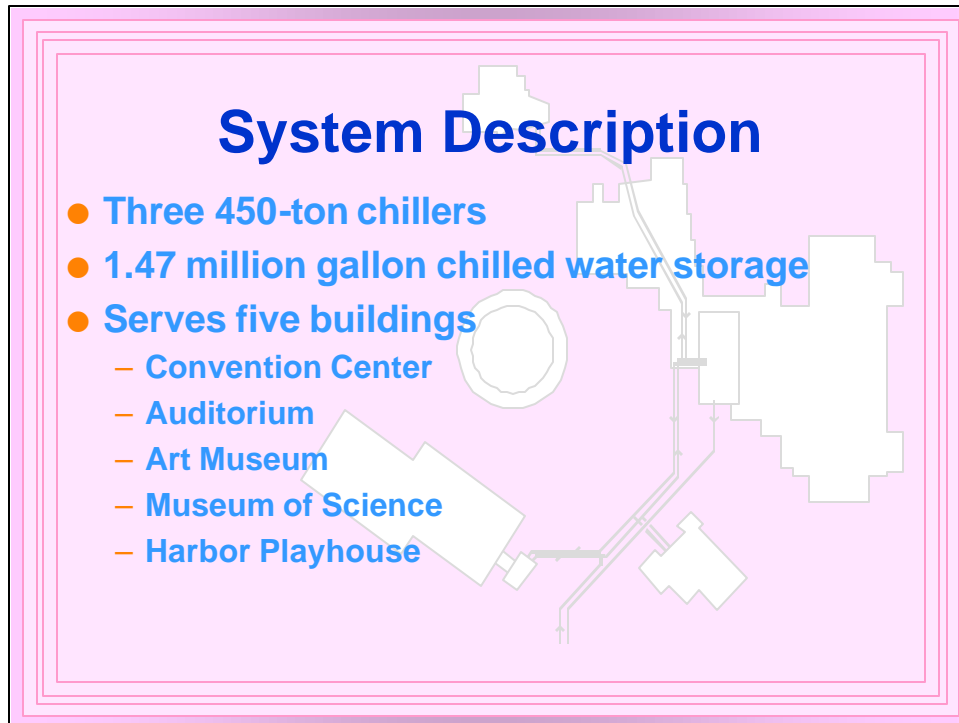
The district cooling plant consists of three centrifugal chillers each rated at 450 tons cooling capacity, a 1.47-million-gallon chilled water storage tank, and associated pumps, cooling towers and piping. The chillers are rated at 450 tons capacity and 0.80 kW/ton when chilling 900 gpm of chilled water from 54°F to 42°F.

The chillers are piped in parallel, each with its own 50 hp pump, with common supply and return headers. Two 200-hp variable-speed secondary pumps, one of which is a backup, circulate water to the five buildings served by the system. The storage tank is piped between the connection of the chiller supply to the secondary pumps, and the chilled water return from the buildings.

The chilled water storage tank is designed to store 13,800 ton-hours of cooling, with a 15°F temperature differential (40-55°F).

The chillers and pumps are located in a mechanical room in a lower level of the Convention Center. The storage tank is located about 500 feet to the west of the mechanical room. The five buildings are located at distances of 150 to 350 feet from the mechanical room.
